**Lead Des 1801915**  
**Appendix F**  
**Waters of the US Report**

**Waters Report  
Railroad Grade Separation Project  
City of Wabash, North East St, from north of Maple St to Hill St  
Wabash County, Indiana  
Des. 1801915**

Report Completed on: August 3, 2021

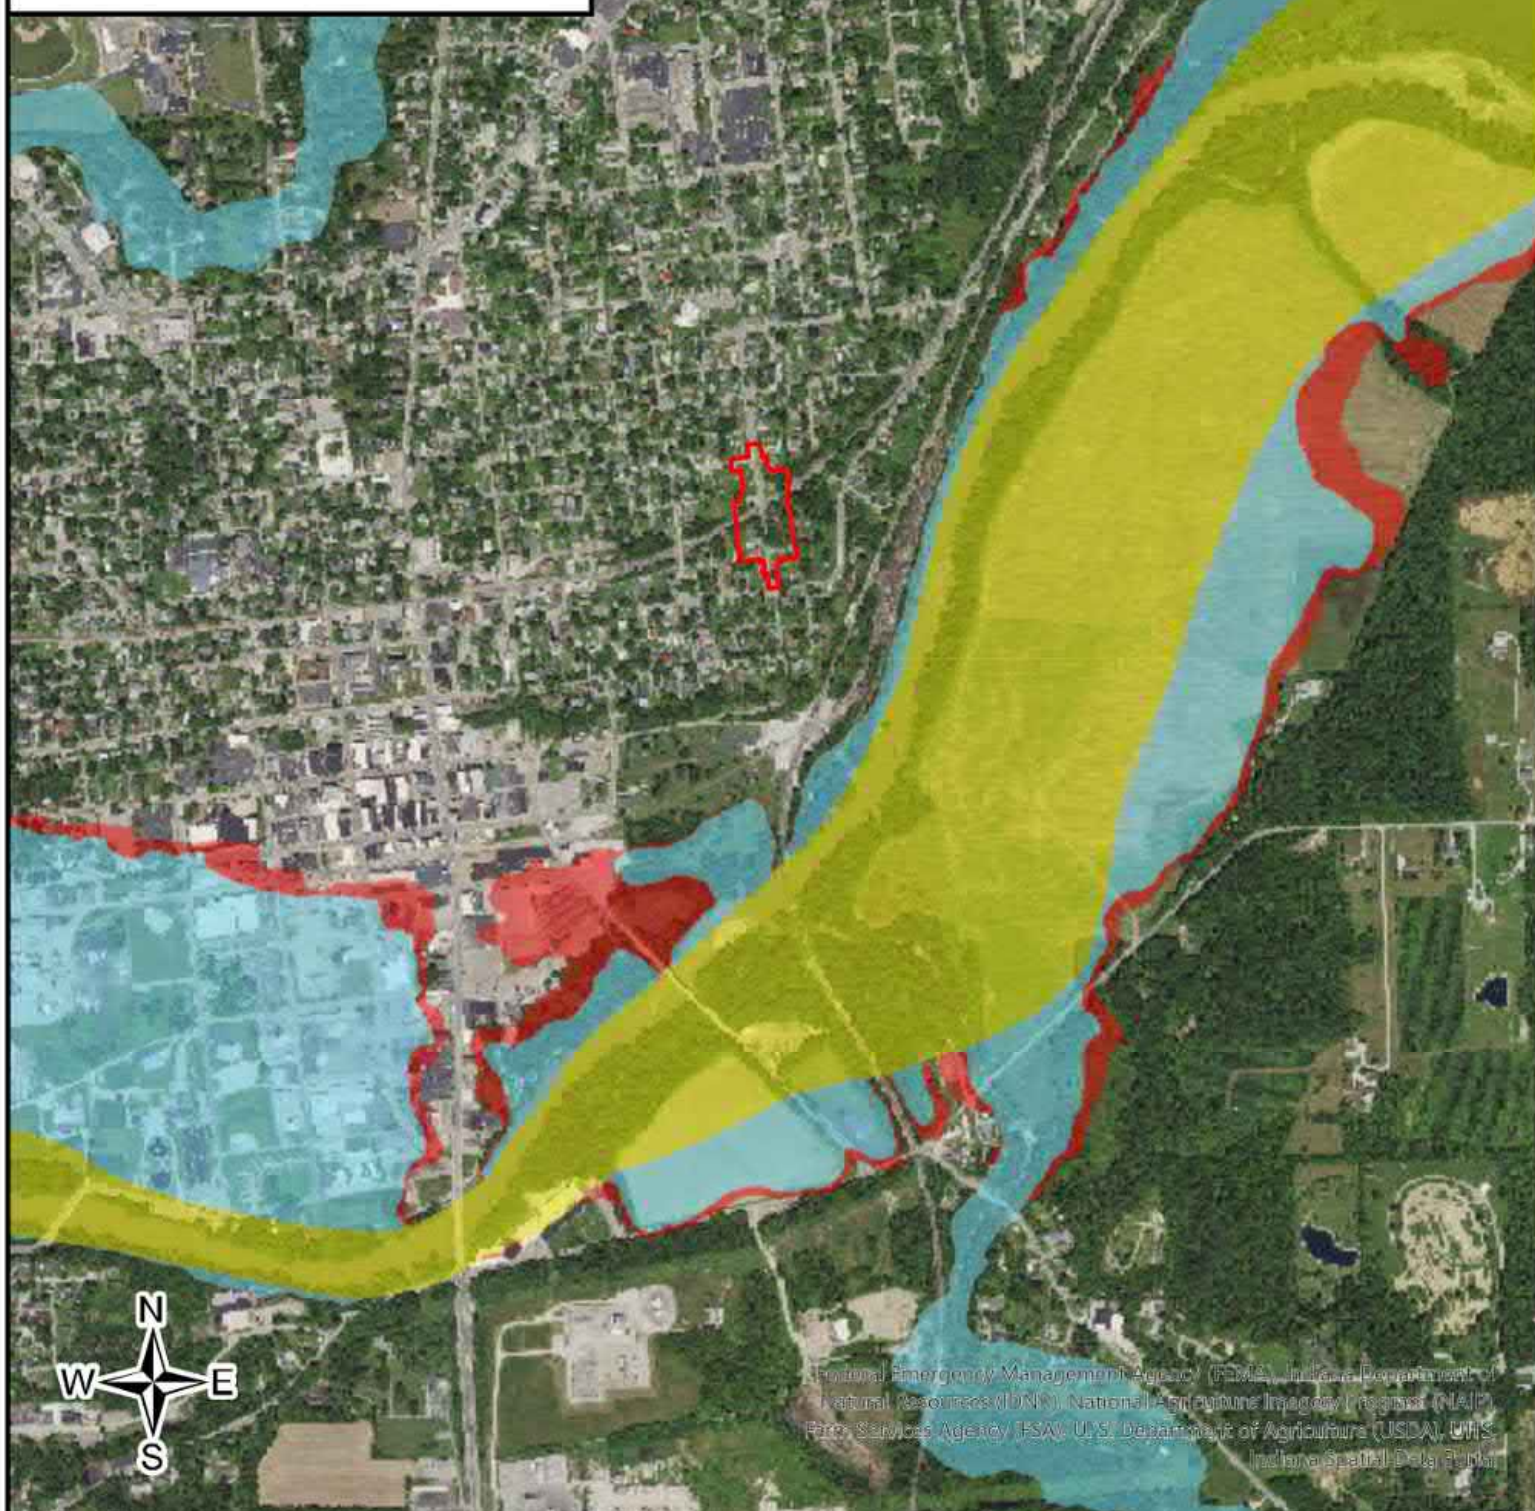
Floodplain Map (1:12,288)  
 Railroad Grade Separation Project  
 North East St, from north of Maple St to Hill St  
 Des. No. 1801915  
 Wabash County, Indiana  
 Source: FEMA, IDNR, & NAIP 2016 Imagery

- **Hydrology:** According to the Indiana Department of Natural Resources (IDNR) Best Available Flood Hazard Area dataset (see attached Floodplain Map), the investigated area is not in a mapped floodplain. No streams are mapped within the investigated area (see attached NWI map). Based on the National Hydrography Dataset (NHD) (see attached NHD Flowlines map), one unclassified flowline segment is mapped along the northwest and southeast quadrant of the railroad corridor. This unclassified flowline segment is labeled as an artificial path and does not correspond with any observed features.

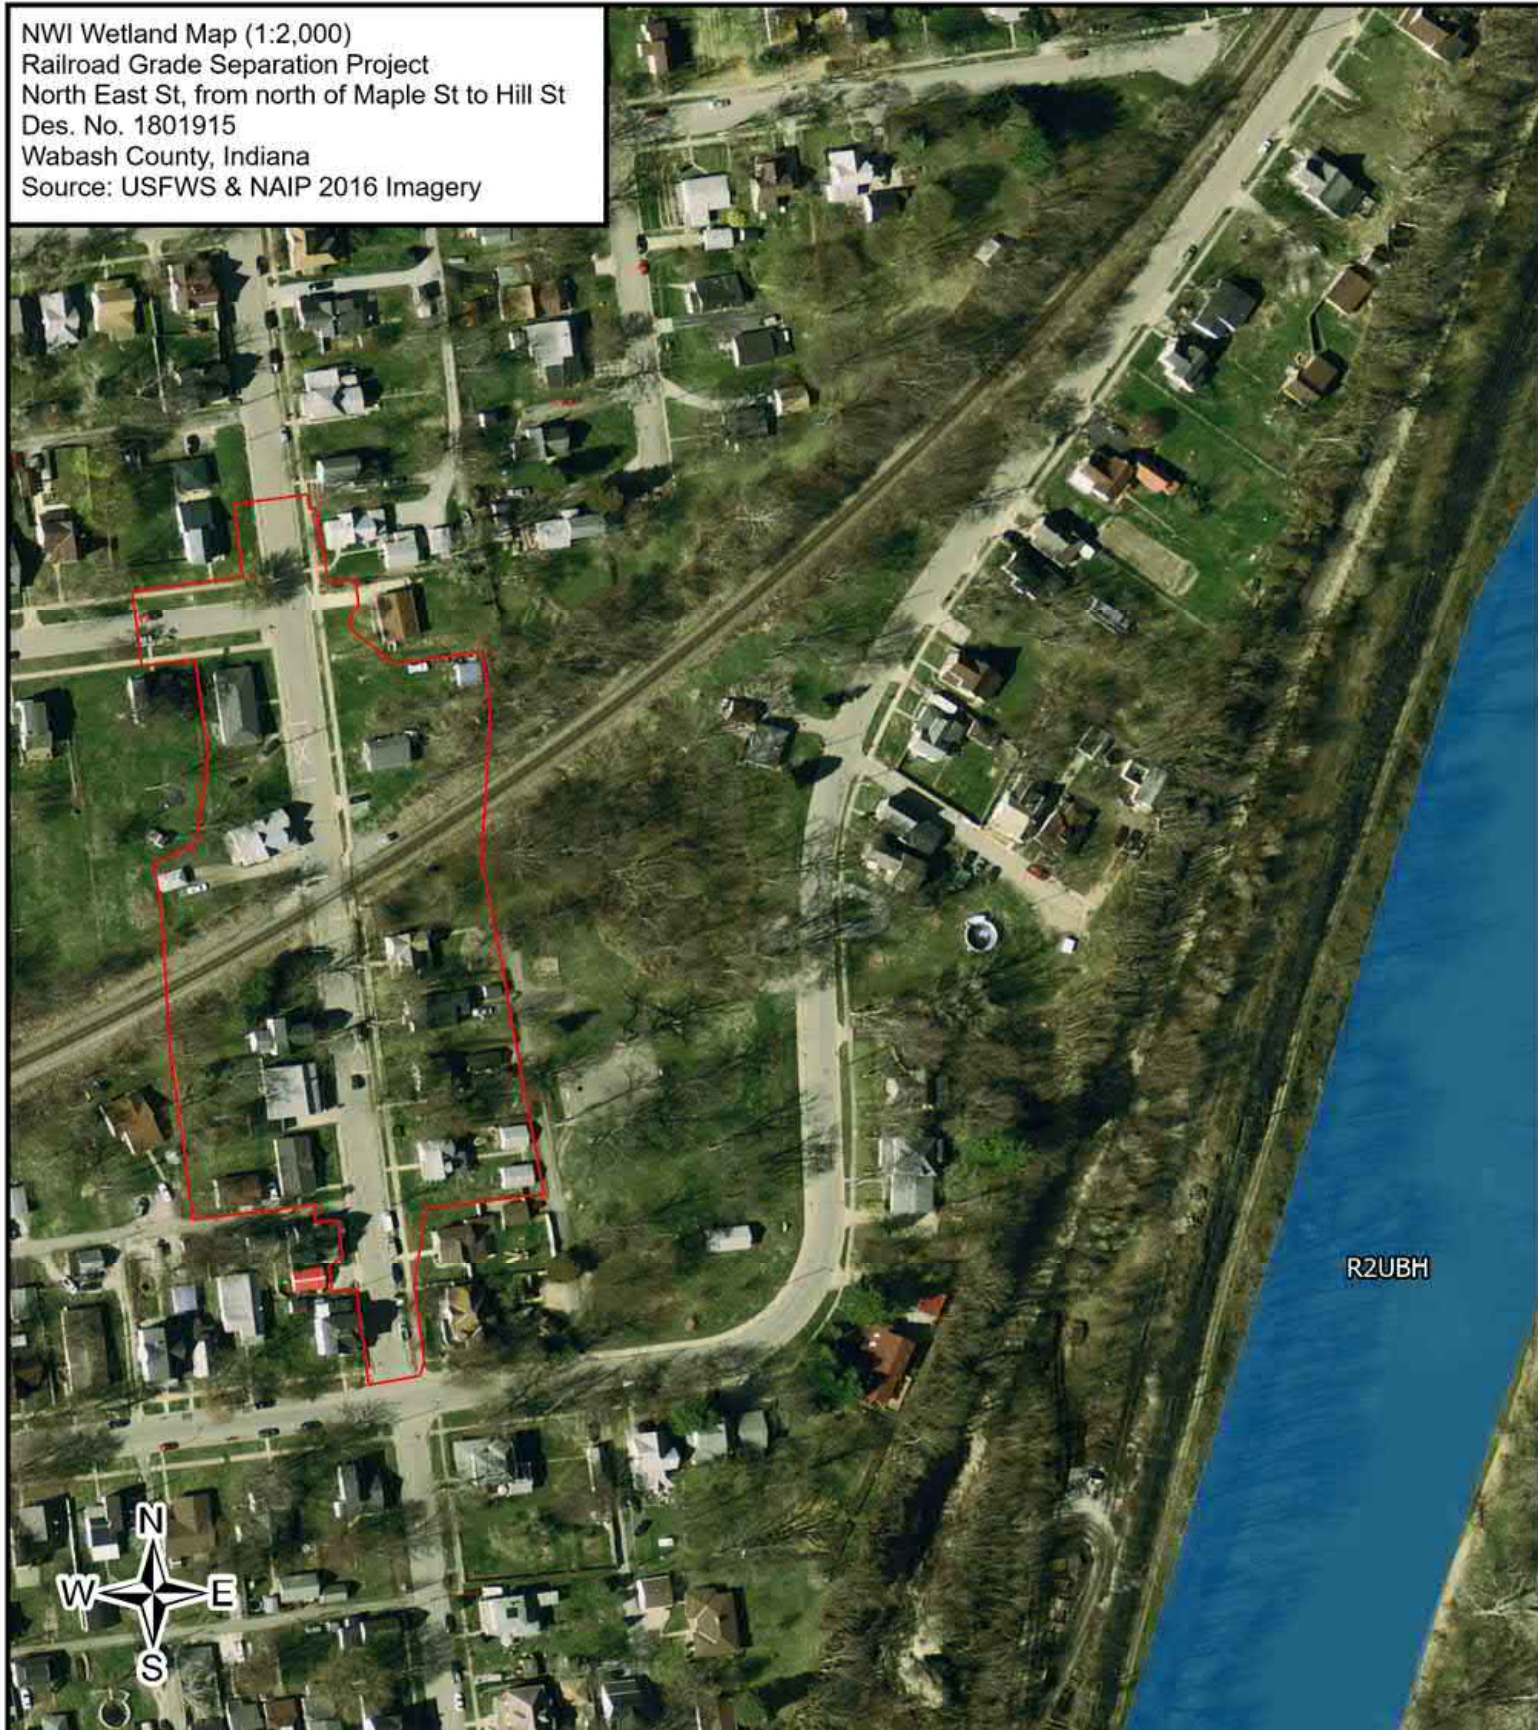
NWI Wetland Map (1:2,000)  
 Railroad Grade Separation Project  
 North East St, from north of Maple St to Hill St  
 Des. No. 1801915  
 Wabash County, Indiana  
 Source: USFWS & NAIP 2016 Imagery

- **NWI Data:** According to the NWI map, no wetlands are mapped within the project area.
- **Site Conditions:** Site conditions were typical for mid-July. No precipitation was recorded during the five days prior to the site investigation (according to weather.com). Temperatures were considered average during the site investigation, with temperatures in the mid-seventies (° F).

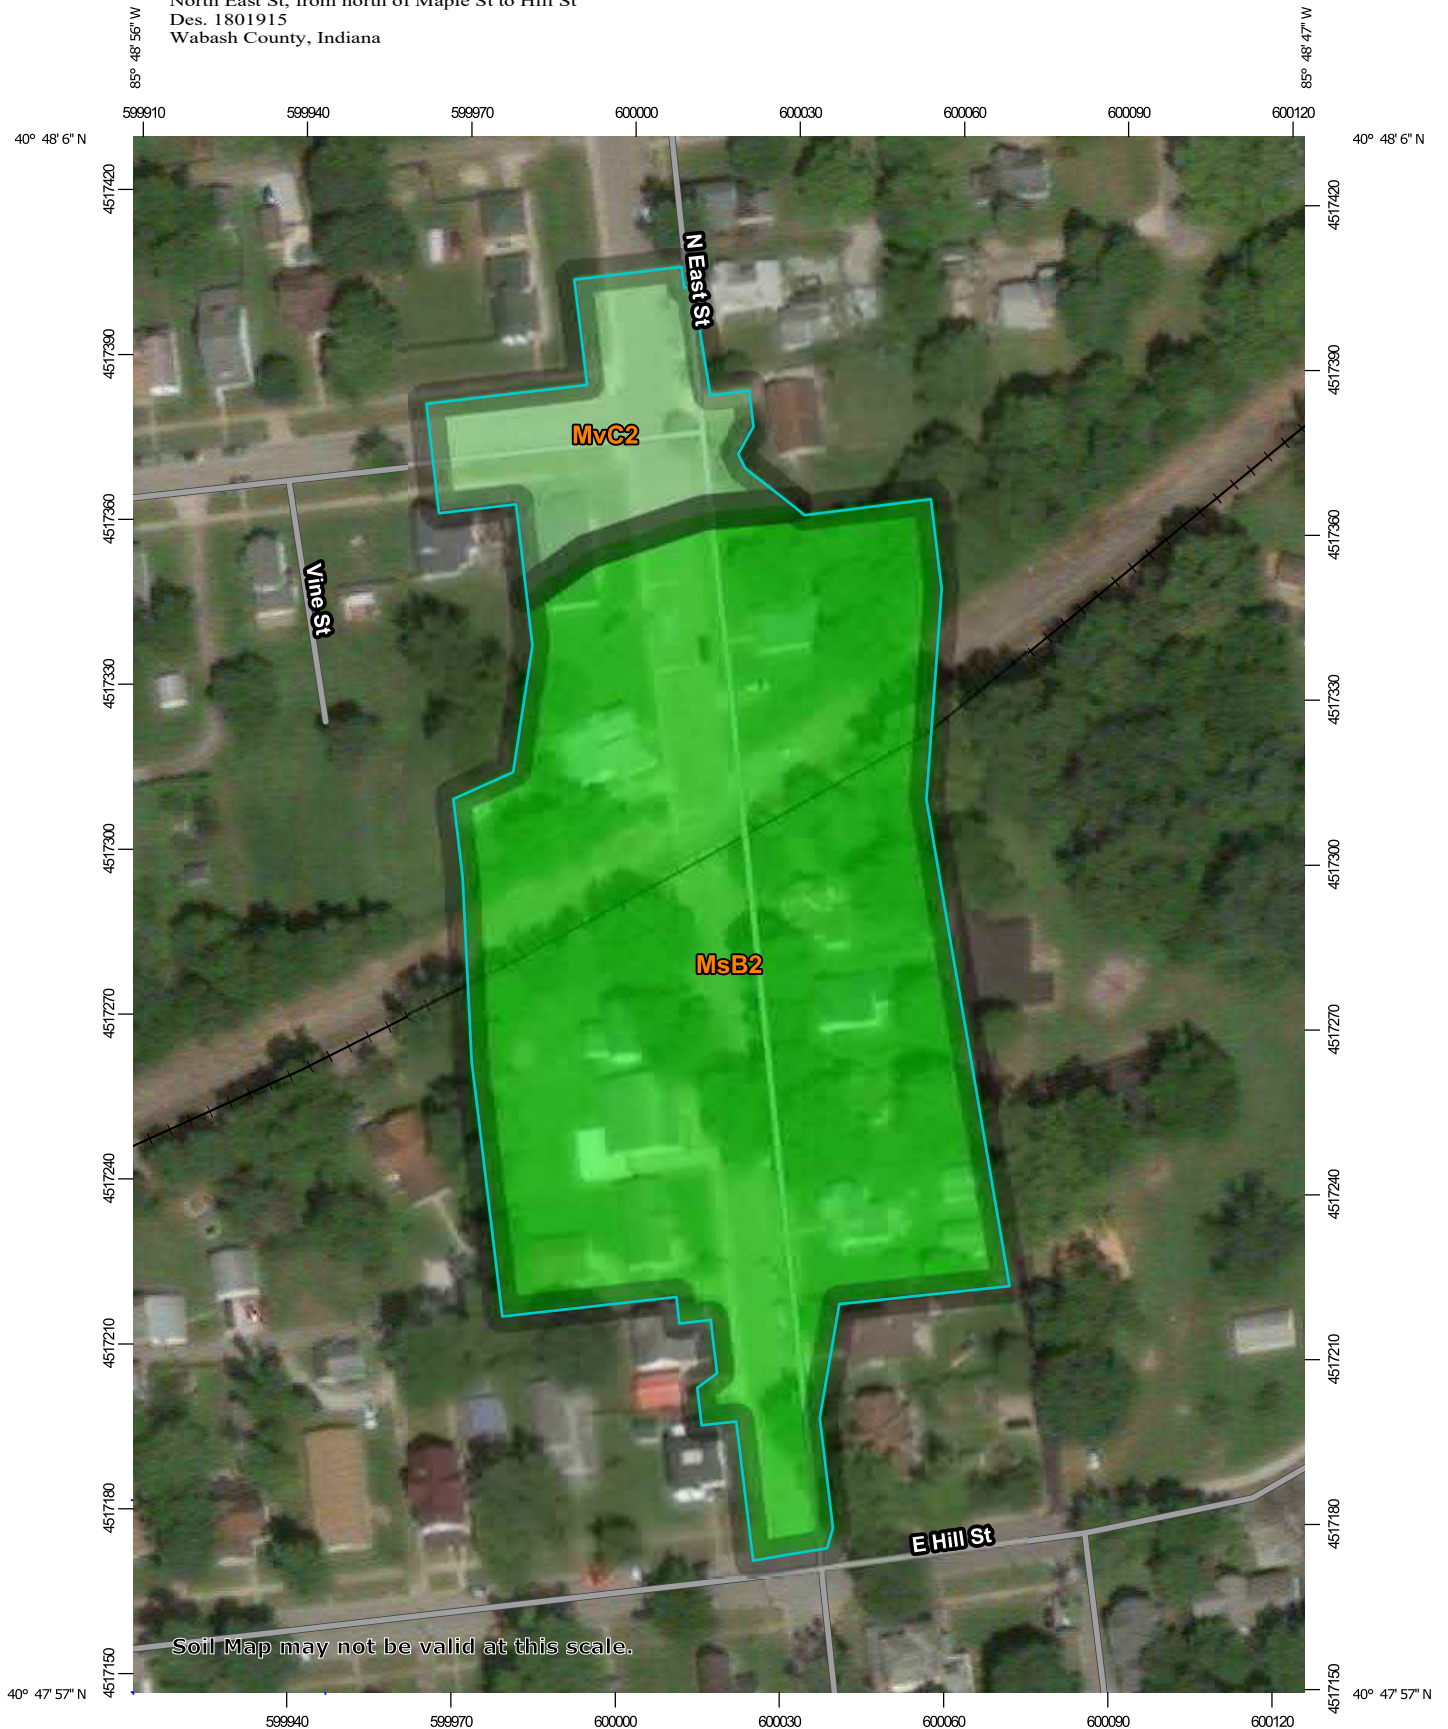
Soil Map  
 Railroad Grade Separation Project  
 North East St, from north of Maple St to Hill St  
 Des. 1801915  
 Wabash County, Indiana

Map unit symbol	Map unit name	Rating	Acres in AOI	Percent of AOI
MsB2	Milton silt loam, 2 to 6 percent slopes, eroded	0	3.2	86.8%
MvC2	Morley silt loam, 6 to 12 percent slopes, eroded	3	0.5	13.2%
<b>Totals for Area of Interest</b>			<b>3.7</b>	<b>100.0%</b>

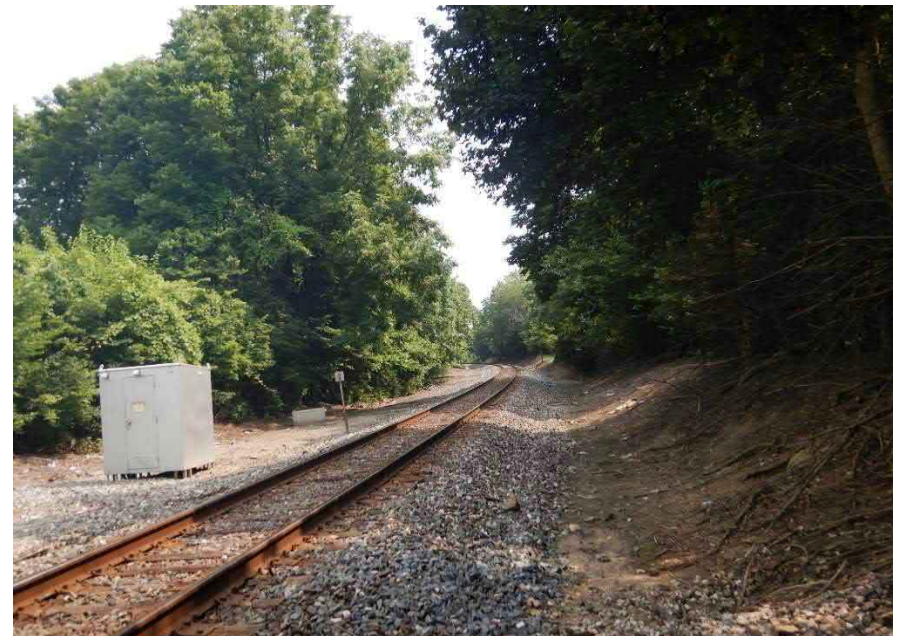
*Photo 8. Facing east along railroad corridor.*

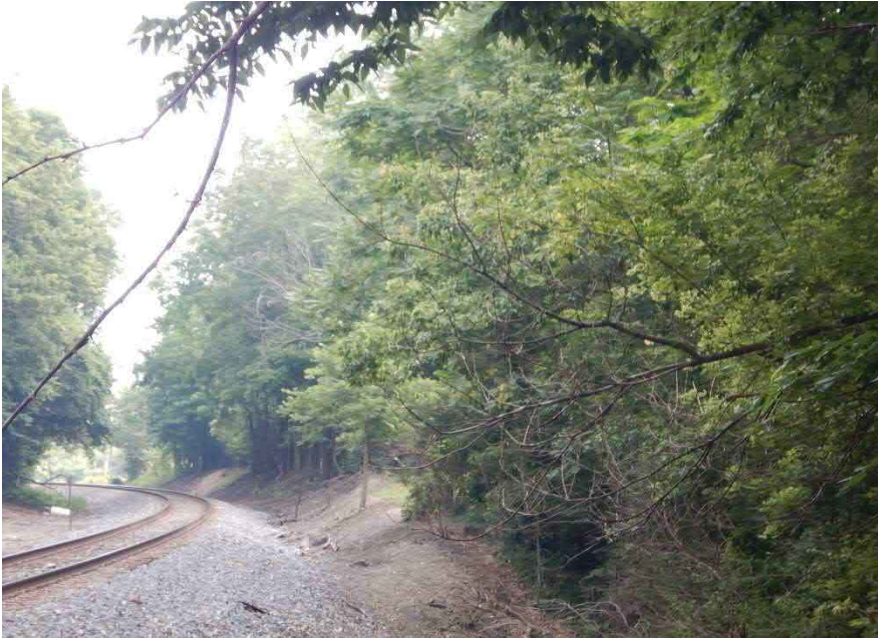
*Photo 9. Facing east along railroad corridor.*

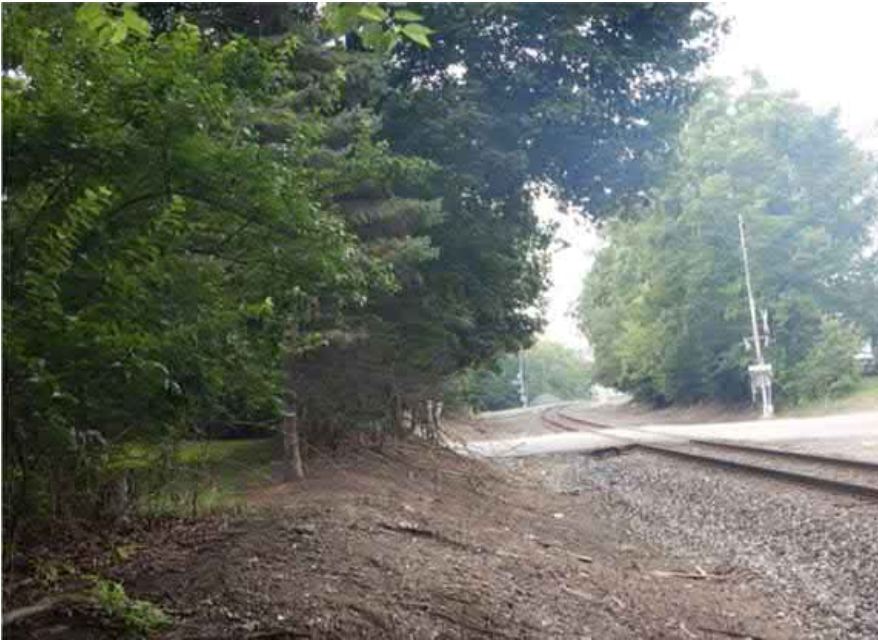
*Photo 10. Facing west along railroad corridor.*
